CASE STUDIES

East Farm, Kirknewton, Wooler

Conversion of a group of redundant early 19th century farm buildings to form a house with ancillary holiday letting unit. Some of the buildings form pavilions and shelters to an enclosed garden to the South of the house.

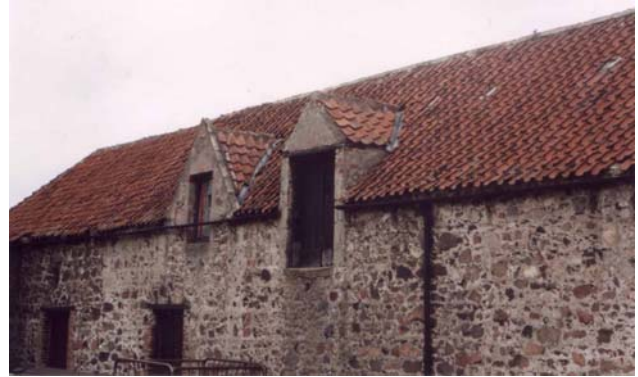
A typical situation where traditional farm buildings have been separated from the land they served and stood empty for many years. Eventually sold to the present owner who has completed the conversion of the main two-storey barn and a gin-gang behind and is in the process of converting the implement shed to a family annexe. There is plenty of space round the buildings and a number of further calf shed and shelters (narrow open-fronted monopitch structures with cast iron columns supporting the front beam lintol).

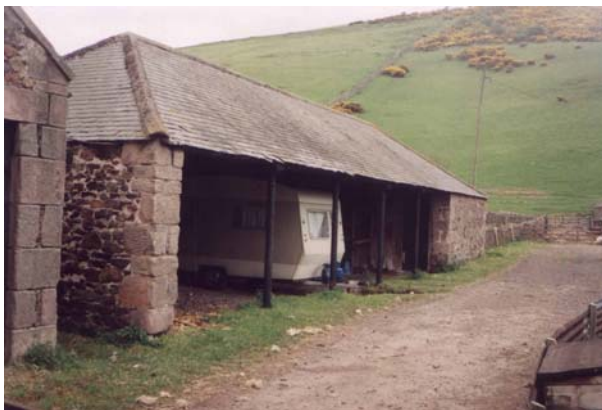
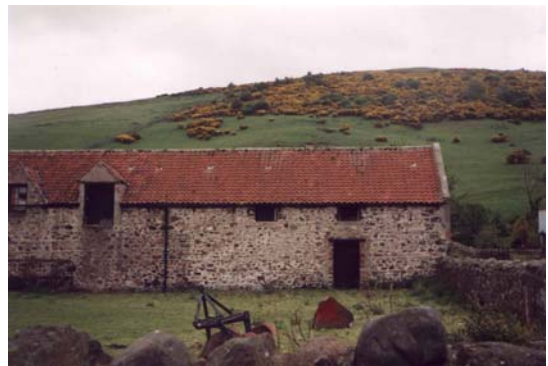
Condition of buildings before conversion

The main barn walls are random rubble with a colourful mix of sandstone and Andesite (the local igneous rock of Cheviot); heavy harling some in 20th century cement based mortars, but for the most part an attractive lime mortar with quite coarse sand. Roof was old pantiles with stone ridge and hip covers, no chimneys, cast iron gutters. The gin-gang against the South side of the barn roofed in Welsh slate as are all the other structures. Cast iron columns on stone pads support the roofs of the implements shed and the various shelters.

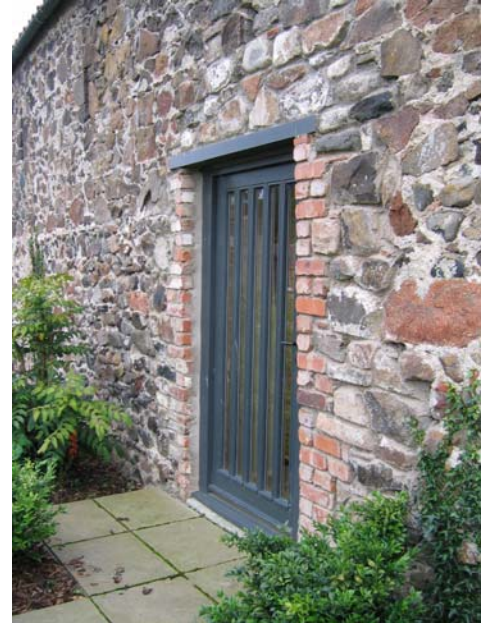
A new doorway in the barn: reused brick defines the alteration

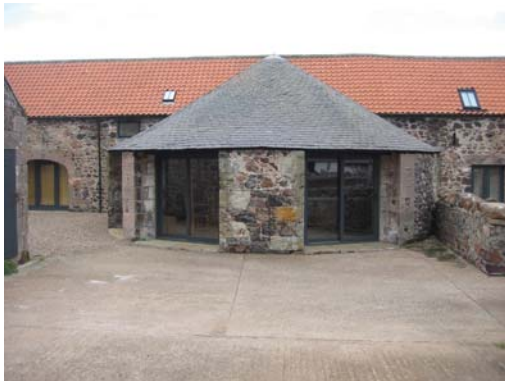
The free standing implements shed to the East of the group had an open front of five bays with cast iron columns supporting the roof plate. This building is slate covered with only one rooflight introduced on the back elevation. The screen that fills the front passes behind the columns so that they still read against the dark paint of the screen. Unfortunately ground level has had to be raised to cover shallow drains and the moulded base of the cast iron columns is lost as well as the padstone.

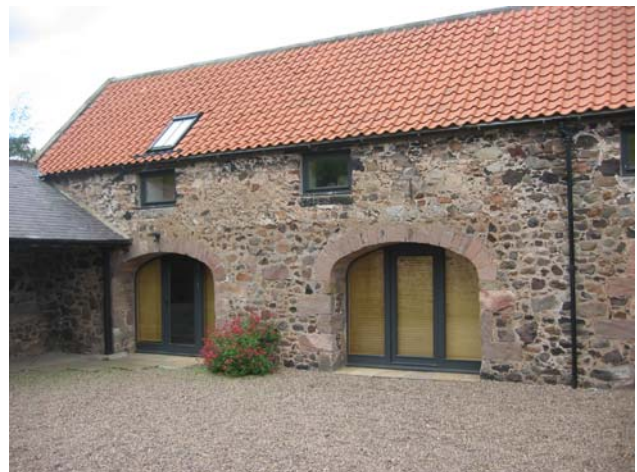
The Gin-Gang with recessed screens

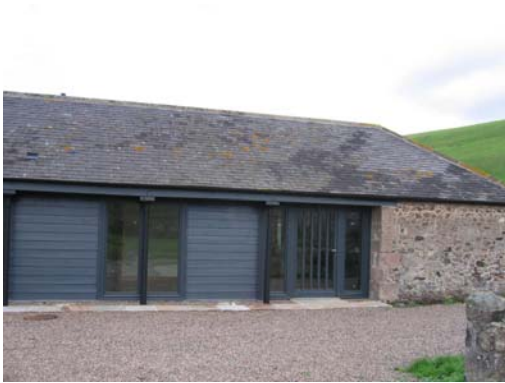
Glazed screen filled hemmel arches

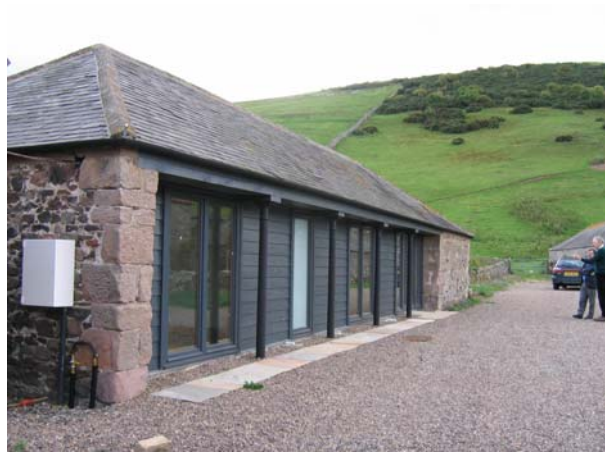
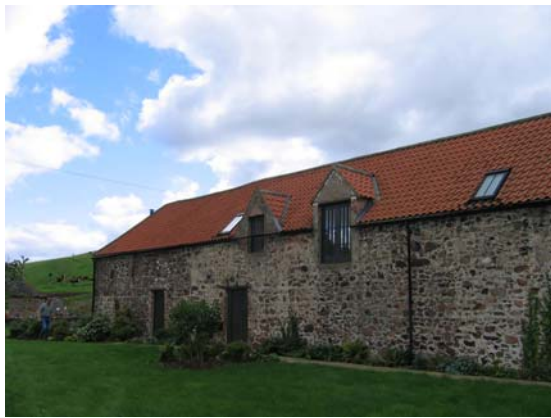
The North wall of the barn/house

In the walls of the barn former ventilation loops have been filled with glass bricks to admit light but not for ventilation. The general theme of painting all external joinery a recessive dark blue does respect the character of the original stained/creosoted boards and becomes the theme throughout the development.
